RESOLUTION OF HIGH AUXILIARY POWER CONSUMPTION OF ESP HOPPER HEATERS BY THERMAL IMAGING

Narayana Teja A and Ganesh C

Bharat Heavy Electricals Ltd, India

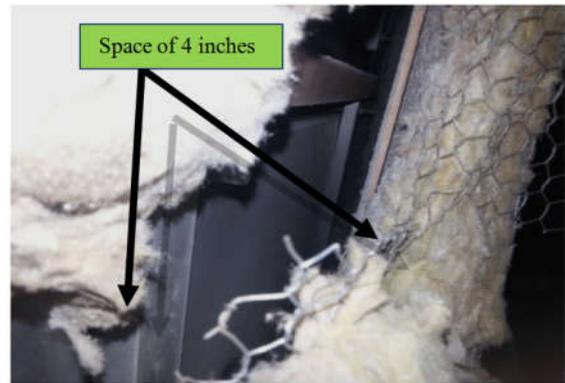
Fig.2 Space between stiffeners, insulation

To verify precision of the insulation erected, one of the ESP hoppers of Unit #3 was selected. Hopper was stripped of cladding sheet on one side, from gate valve upwards by a 3m stretch. A section of the exposed insulation was then cut open and inspected. On investigation, it was observed that there was a gap of 4 inches between the channel (stiffeners) and the surface of insulation wool, as shown in Fig 2. It was also found that the insulation was laid as a blanket sheet from top to bottom onto the hopper surface instead of packing separately in compartments over different heating panel modules.

Air gap extending from top to bottom throughout the slant portion of the ESP hoppers is the cause for heat dissipation to outside locations. To repair the defective insulation, heating panels were first turned off and the surface was allowed to cool. Insulation was then entirely removed from hopper surface as shown in Fig 3.

Fresh insulation material was brought and properly laid onto the stiffeners without leaving any gaps, as shown in Fig 4. The heating modules were subsequently isolated (compartmentalized) by insulation at different elevations.

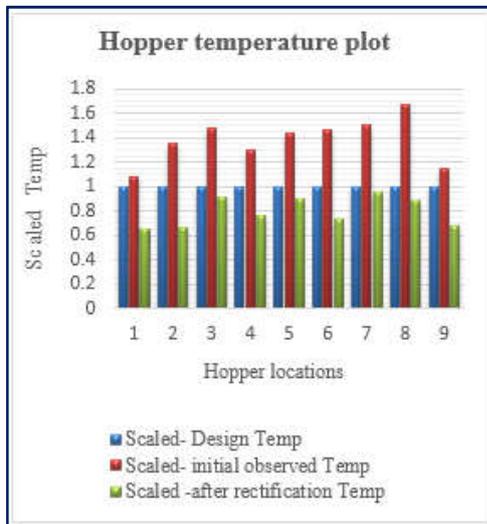
Fig.5 Scaled average hopper temperatures

1. Technique of thermal imagery is utilized in diagnosing the cause for lower hopper surface temperature.
2. Root cause for higher hopper auxiliary power consumption is identified as improper erection of insulation. Repairs have reduced power loss of about 82% over design value for the three units.
3. Thermal Imaging is an important tool that can be implemented in other areas of power plants to diagnose faults.
4. The thermo graphic data collected can be utilized for optimizing insulation thickness.
5. The average scaled data of hopper temperatures, at each of the locations captured, is presented vis-à-vis the design temperature in Fig 5.

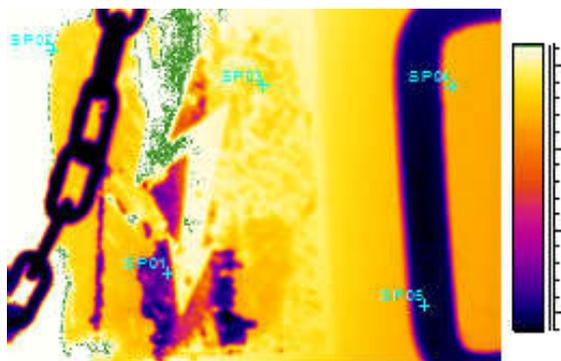
Hopper manhole door

Normalized thermal image sets for a typical hopper in Unit#3 are appended in Annexure-1. Malfunctioning due to improper insulation can be seen with regard to images at different locations, after and before rectification, to comprehend the impact of rectifying the thermal insulation.
