RESOLUTION OF HIGH AUXILIARY POWER CONSUMPTION OF ESP HOPPER HEATERS BY THERMAL IMAGING

Narayana Teja A and Ganesh C

Bharat Heavy Electricals Ltd, India

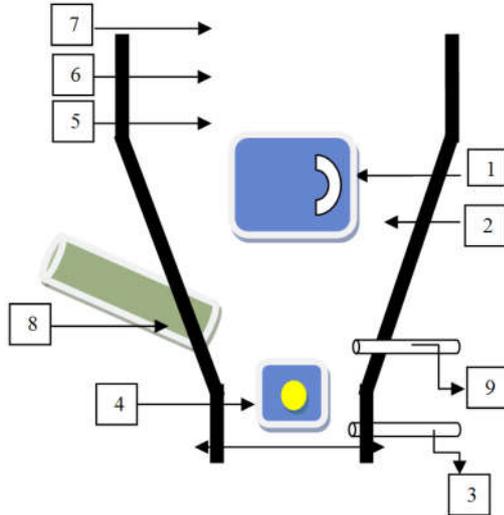
Fig.1. Schematic of hopper

1. Hopper manhole door
2. Aluminium cladding door level
3. Thermostat location (Location1)
4. Anvil
5. Hopper elevation 1(3m)
6. Hopper elevation 2(4m)
7. Hopper elevation 3(5m)
8. Ash Poke hole
9. Thermostat location (Location2)

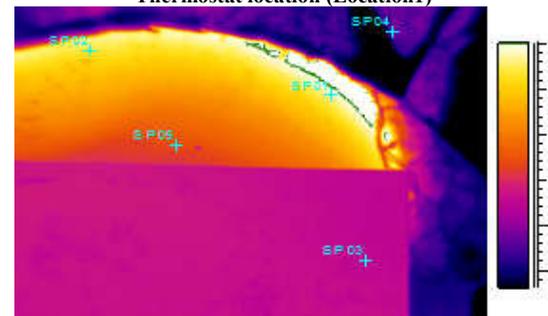
Anvil

Normalized thermal image sets for a typical hopper in Unit#3 are appended in Annexure-1. Malfunctioning due to improper insulation can be seen with regard to images at different locations, after and before rectification, to comprehend the impact of rectifying the thermal insulation.
